Read Instructions Completely Before Installing REV 02/21

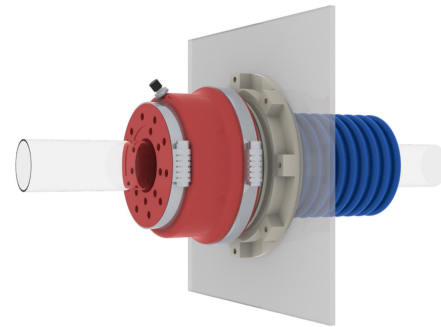
STEP 8

Install both band clamps and tighten to 65 inch lbs. When completed, you may immediately start any line leak and hydrostatic leak testing to confirm a successful repair.
